02S17 Hyland Landfill
Monitor Rpt 2006-2007

MONITORING REPORT

FACILITY NAME: Hyland Landfill
FACILITY NUMBER: 02 S 17
DATE: July 22, 2008
REPORTING PERIOD: December 2007
FACILITY MONITOR: Richard Stroh RRS
DAYS AT SITE: 12/3, 12/11 and 12/26

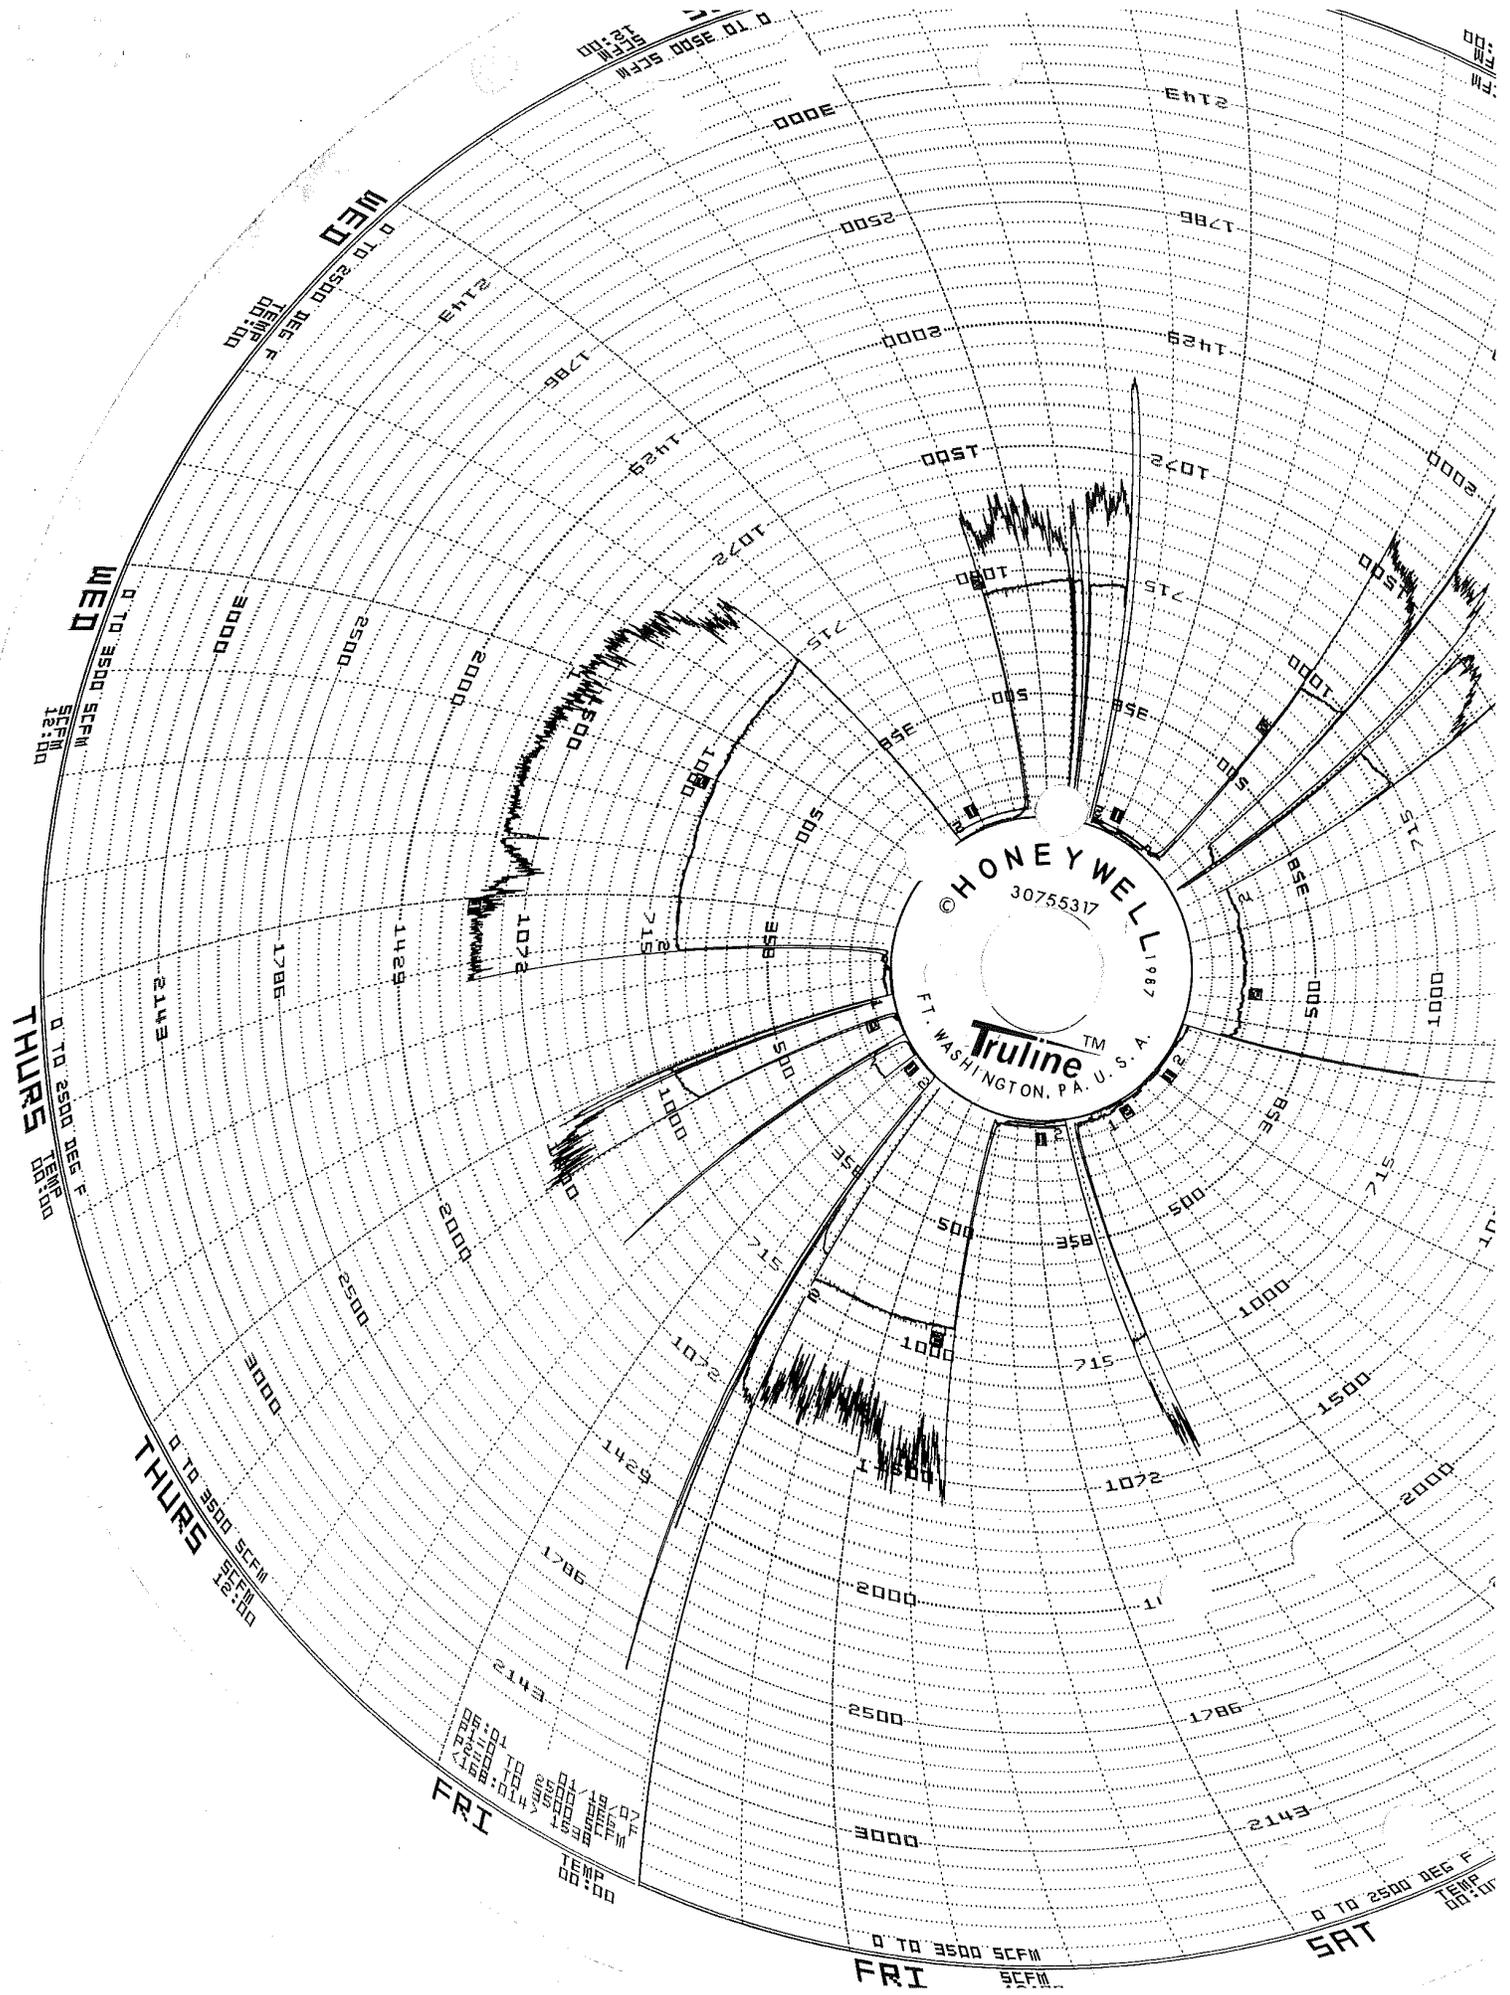
The gas flare operated during the month with a flow of 1,500 SCFM. An inspection of the flow chart of 12/12 through 12/18 indicated that the gas flare shut down on the evening of Saturday 12/15 through Monday morning 12/17. An inspection of the flow chart of 12/19 through 12/25 indicated that the gas flare shut down the evening of Saturday 12/22 through Monday morning 12/24, running for three hours on Sunday. A copy of the flow chart is attached. Odor complaints were received on 12/7 and 12/18.
