Monitoring Report

Facility Name: Hyland Landfill

Facility Number: 02S17

Date: January 17, 2012

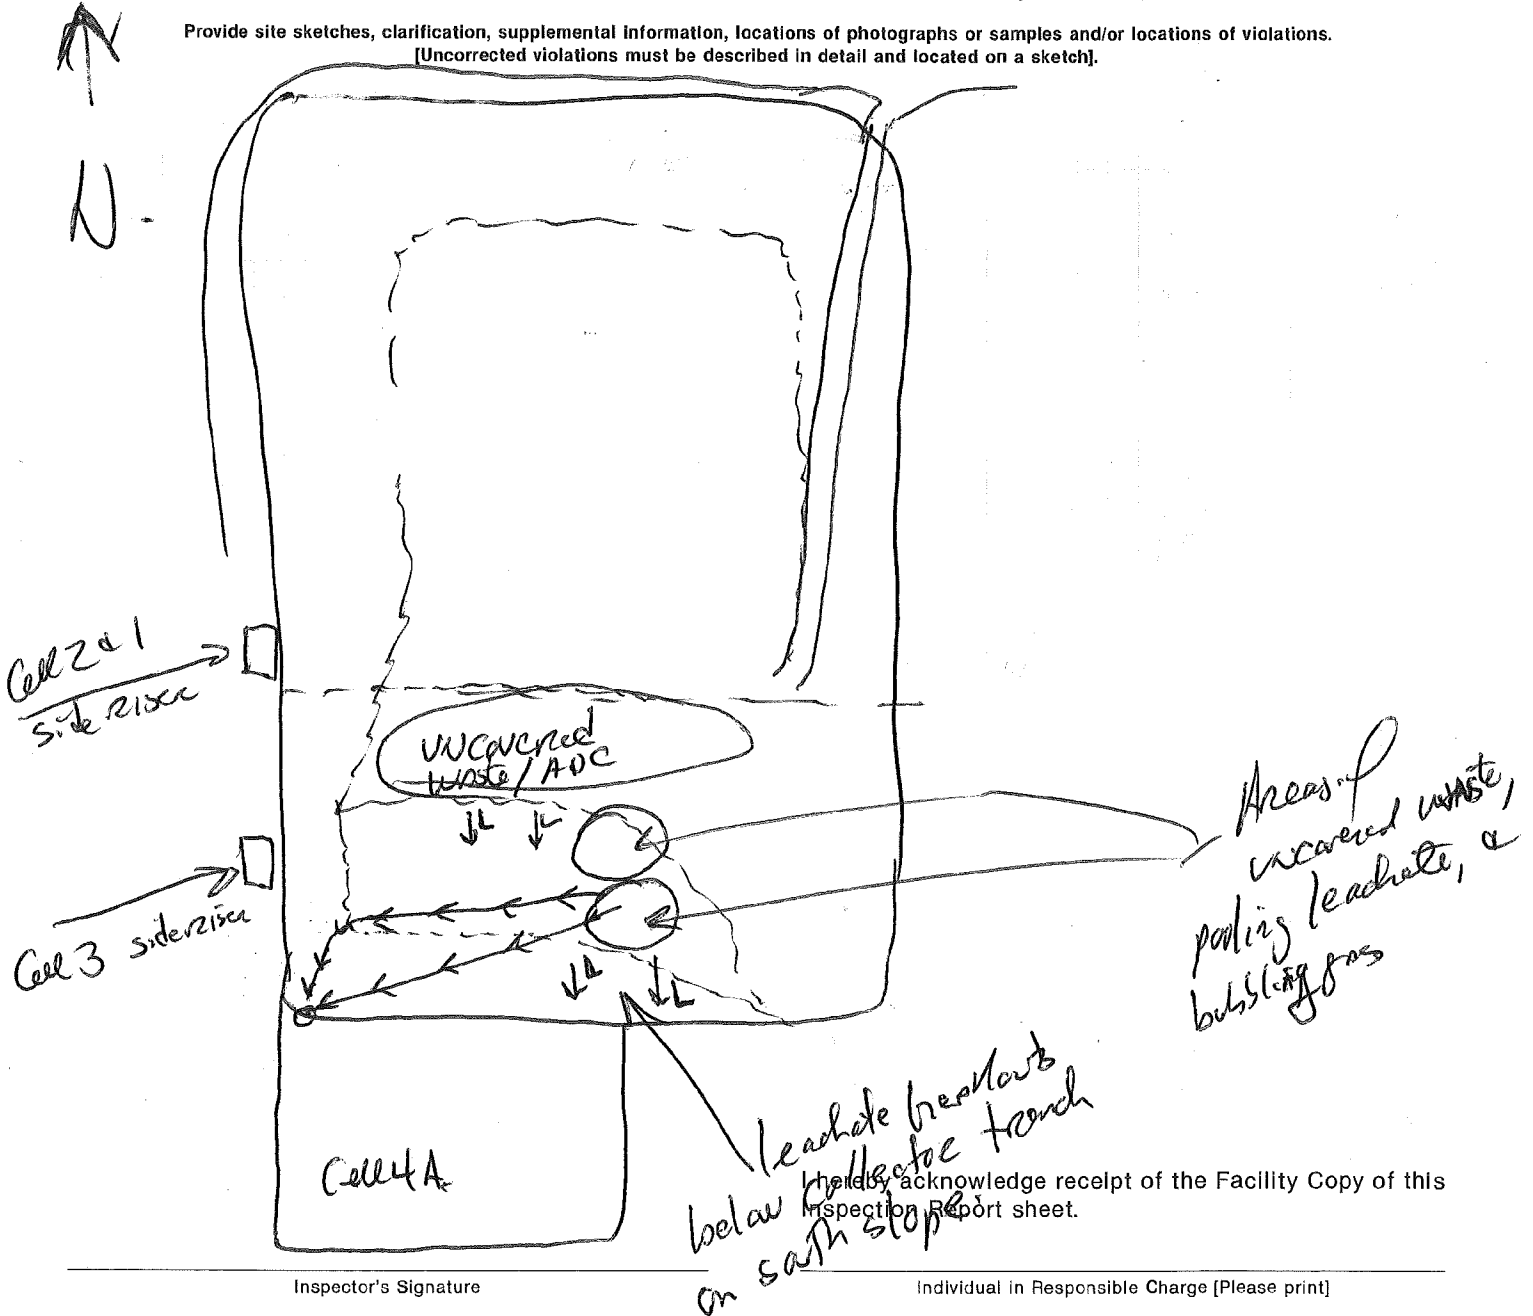
Despite 6 weeks to address the previously noted problems, most remain. These were supposed to be addressed by 9/30/11. Progress has been made, but the issues still remain.

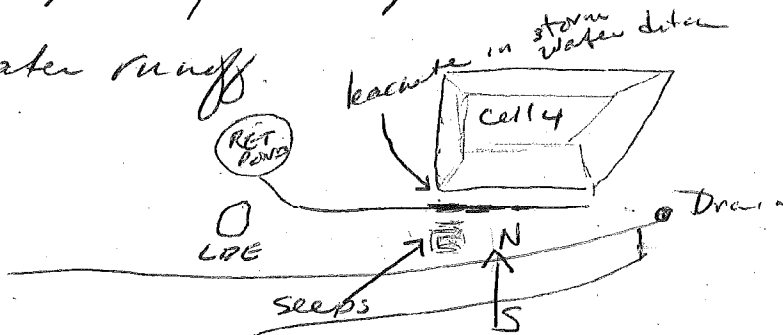
South slope - priority - leachate in storm water runoff.

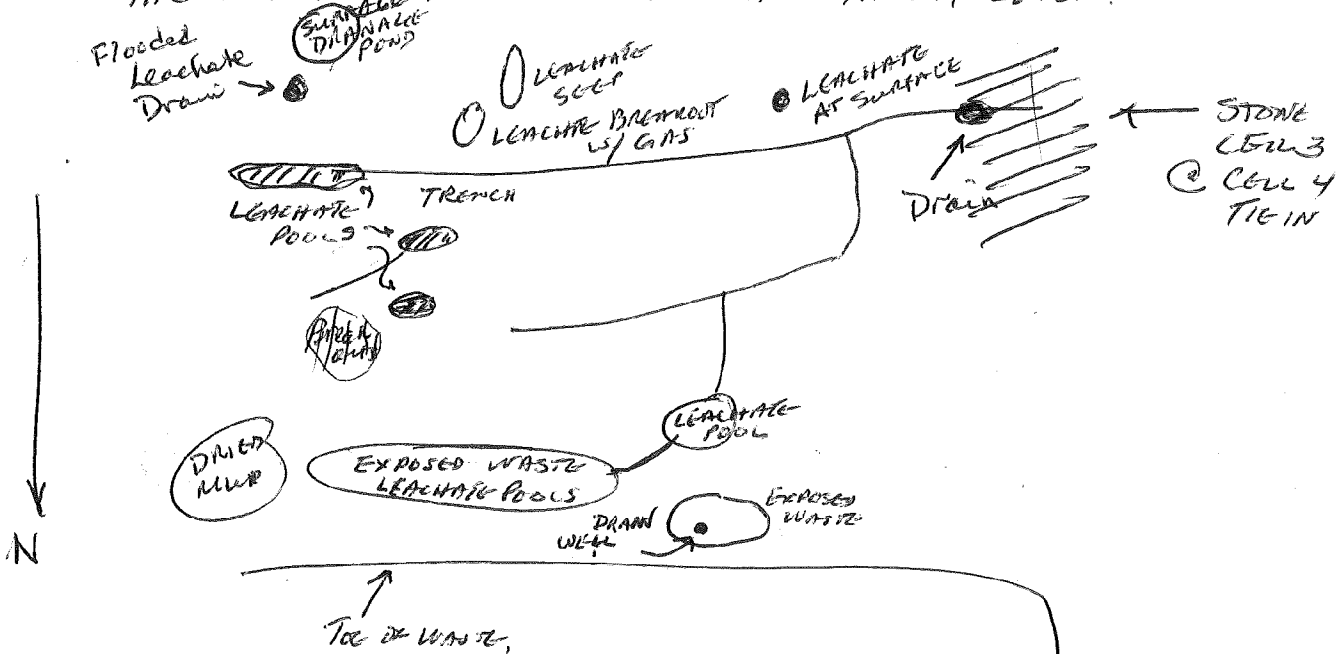
10. LEACHATE MINIMIZATION: ① CURRENT CORRECTIVE ACTIONS TO CAPTURE LEACHATE BREAKOUTS INCREASE LEACHATE GENERATION BY COLLECTING SURFACE WATER RUNOFF ON SOUTH SLOPE ② LEACHATE BREAKOUTS ON SOUTH SLOPE BETWEEN A LEACHATE CAPTURE TRENCH AND THE TOE OF THE SLOPE ALLOW LEACHATE TO ENTER/BECOME SURFACE WATER RUN-OFF ③ A LEACHATE DRAIN OVERFLOWS AND RELEASED LEACHATE INTO SURFACE RUN-OFF ON 8/14 IN A HEAVY RAIN STORM. (CORRECTIVE ACTIONS ARE BEING DONE) ④ THE TOP OF CELLS 1 & 2 GENERATE LEACHATE OUT OF NECESSITY BECAUSE THE SURFACE DOES NOT HAVE AN INTERIM COVER.

- ⑤ LEACHATE BREAKOUT ON SOUTH SLOPE BY LINER TEAR
⑥ LEACHATE PUMP - CELL 2 PRIMARY @ 16 gpm, PROBLEM!
CELL 2 PRIMARY @ 47", LIMIT IS 20"

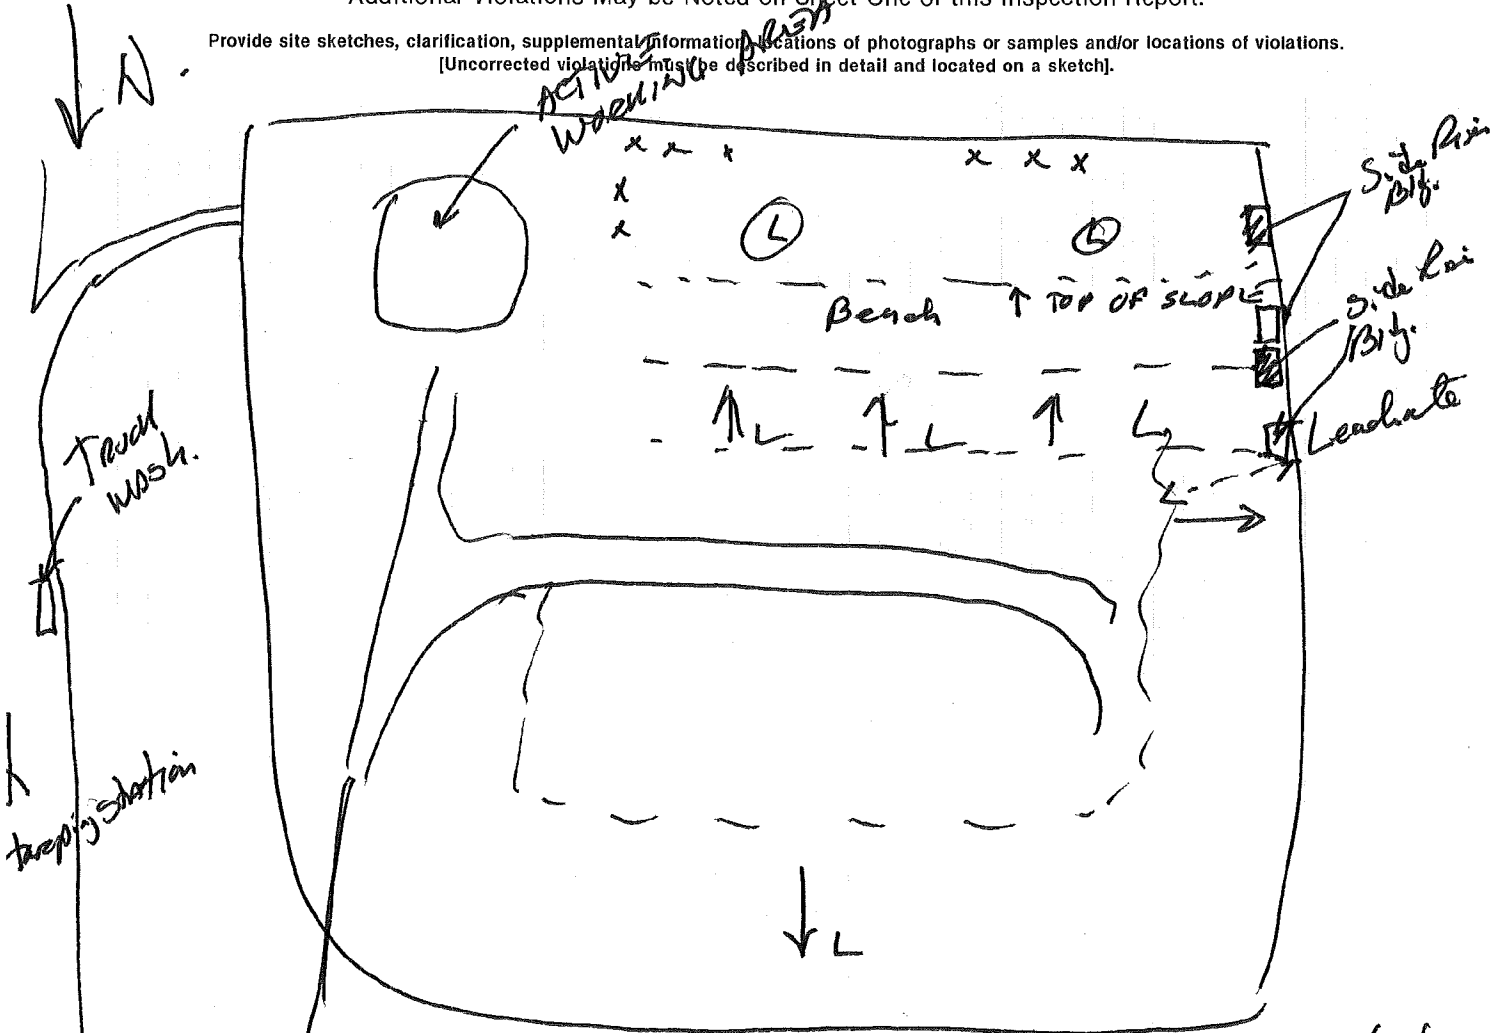
- Leadhate leachate on west & north side despite collection trenches.
- Leadhate breeds & ponding on *South slope/bench*
- due to windy conditions, gusting to 34 mph, lots of windblown waste.
- 2ndary leachate level at 20.3 for Cell 3. No high lead light on!
- Leadhate basin are h/b. Need to continue to remove leachate
